# Manhole Inspection Summary

Manhole # S15EE1013MH

**Location** Address: **3835 DERBY MANOR DR**

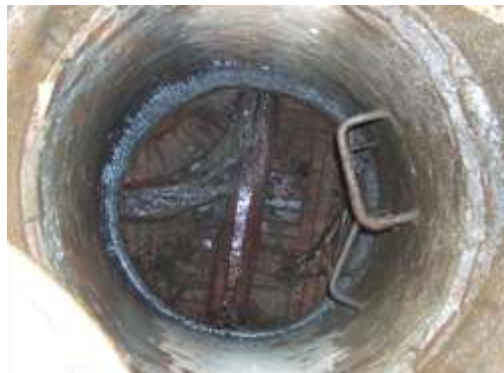
Top View

Evidence of surcharge - Bench debris.  
Corroded steps.

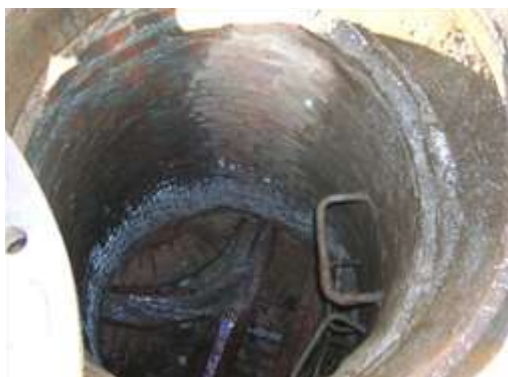
Defect

Frame leaks. Adjustment deterioration  
and infiltration. Barrel infiltration - other  
side.

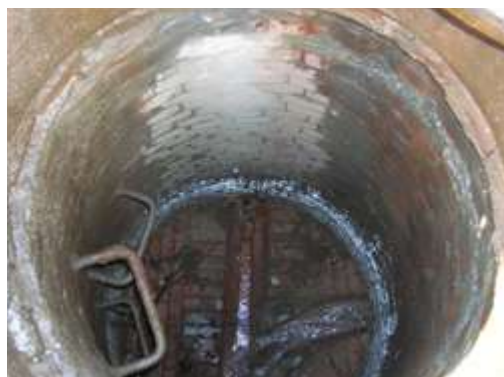
Defect

Frame leaks. Adjustment deterioration  
and infiltration. Barrel infiltration.

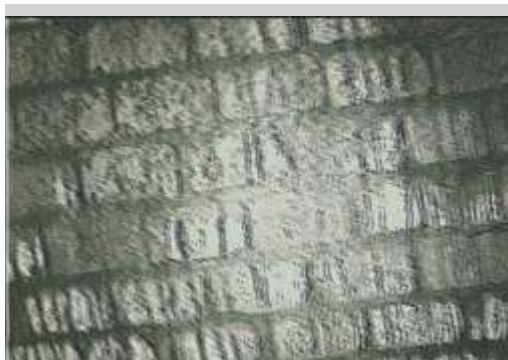
Defect

Barrel infiltration.

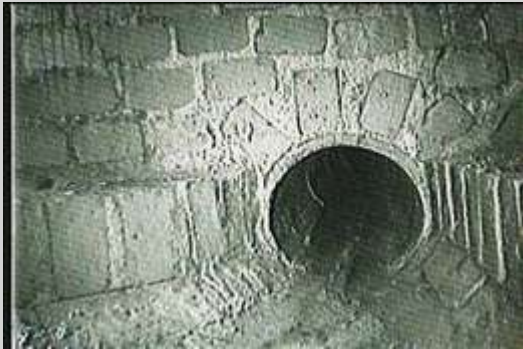
### 8 in. Circular Gravity Sewer Pipe Out @ 12 O'Clock

Infiltration: **Evidence** Pipe Seal Cond: **Unknown**

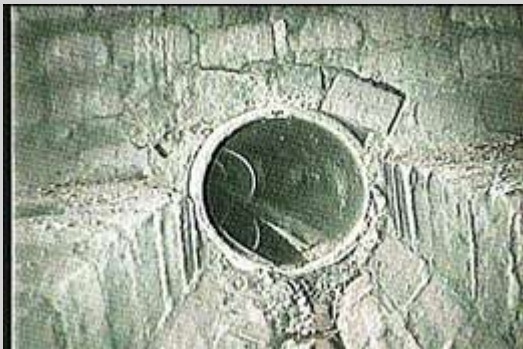
### 8 in. Circular Gravity Sewer Pipe In @ 6 O'Clock

Barrel deterioration and infiltration. Channel deterioration.

Deposits: ☐ None ☐ Mud ☐ Sludge ☐ Debris ☒ Grease

Infiltration: **Evidence** Pipe Seal Cond: **Broken**

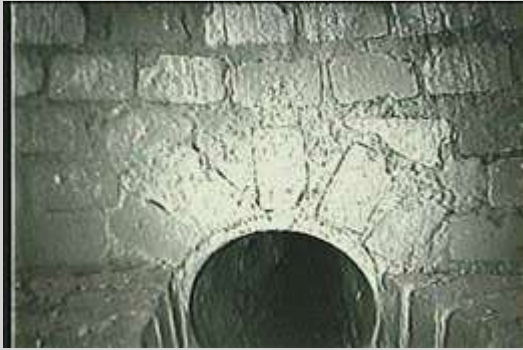
Pipe In @ 9 O'Clock

Infiltration: **Evidence** Pipe Seal Cond: **Unknown**
